US Army Corps of Engineers

HURRICANE KATE STORM SURGE DATA

Report 5

Coastal Engineering Research Center

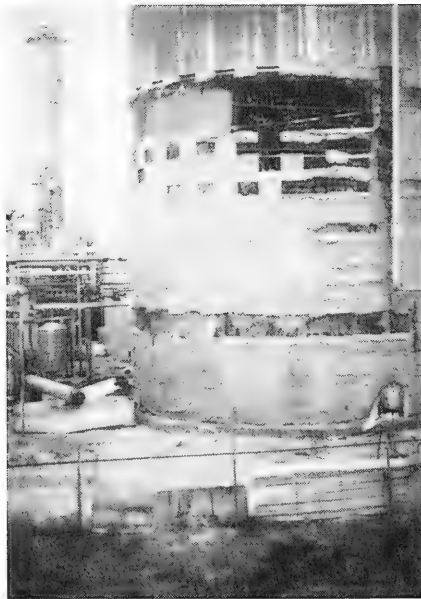
15. The extent of wind damage increased rapidly farther east; an example can be seen by the stripped siding and insulation on a storage tank at the paper company in Port St. Joe (Photo 4). However, the amount of surge damage in Port St. Joe was minimal due to the excellent protection offered by the St. Joseph spit offshore. The spit itself suffered massive erosion, as can be seen by the scarp cut into the duneline at the St. Joseph Peninsula State Park (Photo 5). The combined surge and wave runup at this location exceeded +16 ft.

Photo 4. Damaged tank covering, Port
St. Joe, Fla.

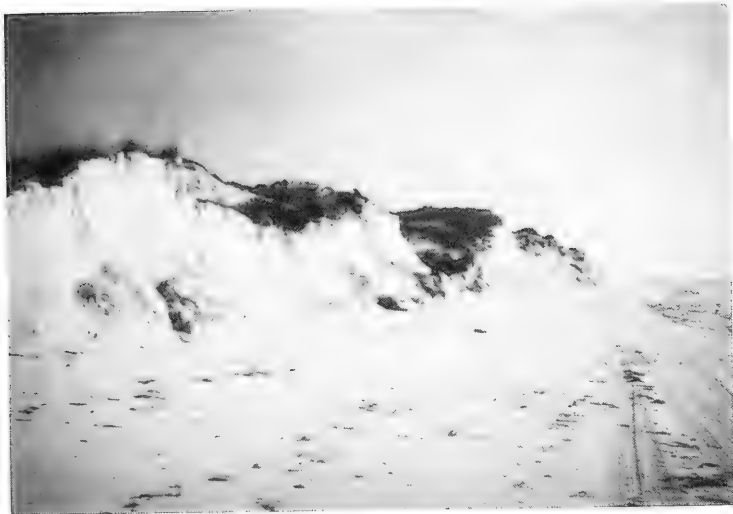
Photo 5. Beach erosion, St. Joseph Peninsula State Park, Fla.

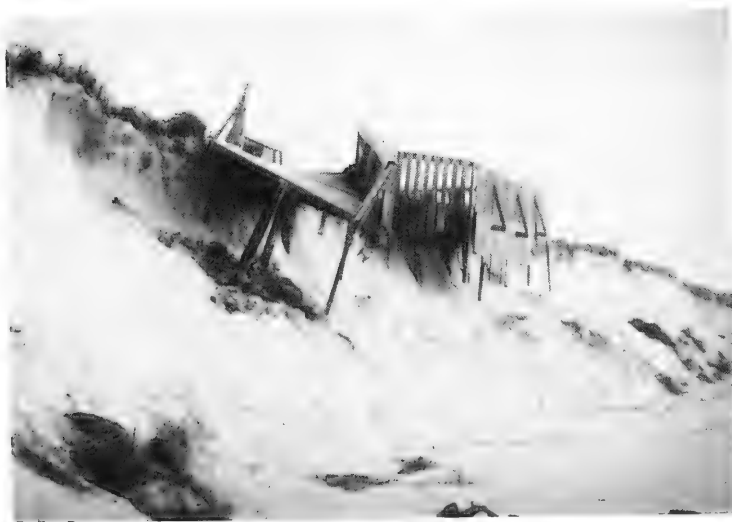
16. Property damage within the park was confined to boardwalks (Photo 6) due to the lack of construction along the beachfront. Farther south at Cape San Blas, there was more extensive damage. Several homes were totally destroyed (Photo 7), and houses that survived were undermined by beach erosion (Photo 8). The surge elevation at this location was approximately at 9 ft. Many of the buildings located far enough from the beach to be protected from surge damage suffered wind damage (Photo 9).

Photo 6. Damaged boardwalk, St. Joseph Peninsula State Park, Fla.

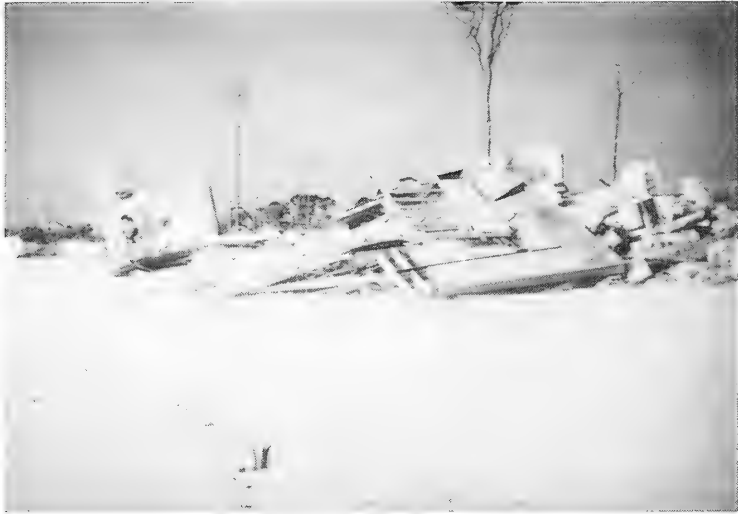
Photo 7. Destroyed house, Cape San Blas, Fla.

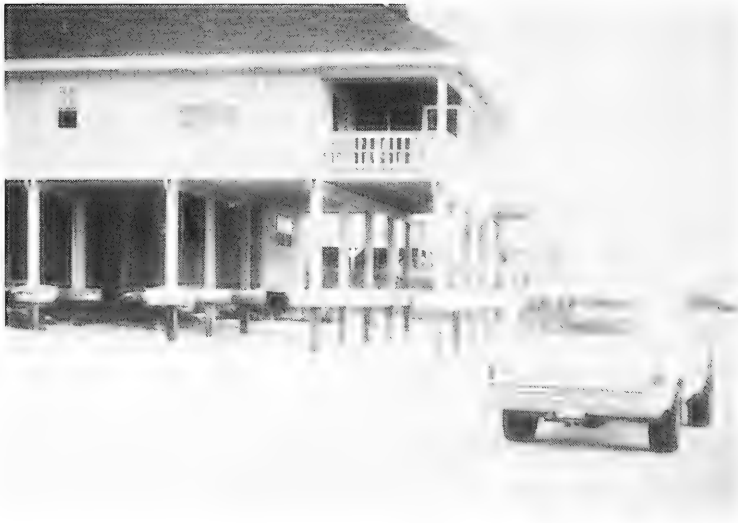
Photo 8. Beach erosion under house, Cape San Blas, Fla.

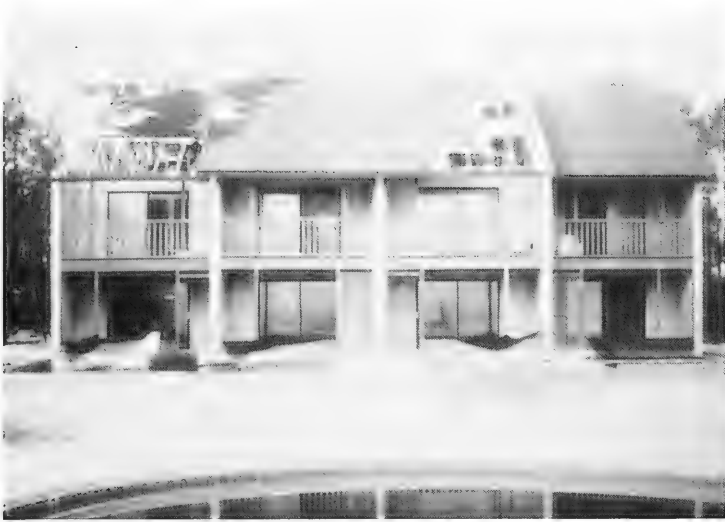
Photo 9. Roof damage, Cape San Blas, Fla.

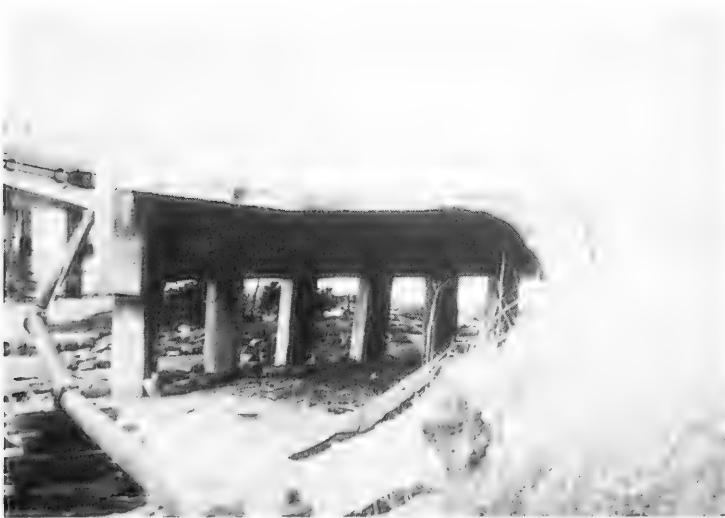
17. An attempt was made to survey St. George Island; however, surge-induced flooding had undermined the approach ramp at the mainland end of the

bridge to the island, cutting off all vehicular access (Photo 10). Damage was significant on the protected mainland coast behind the island. Several miles of Highway 98 along the coast between Cape San Blas and Carrabelle were undermined and had collapsed (Photos 11 and 12). The Hut Restaurant in Apalachicola was completely destroyed (Photo 13). Between East Point and Carrabelle, several homes and trailers located on waterfront lots were totally destroyed (Photos 14 and 15). Farther east, at Lighthouse Point, there was more destruction (Photo 16). Throughout this area, surge elevations were approximately 7 ft. Wind and surge damage, although less severe, was reported as far east as Cedar Key, Fla.

Photo 10. Highway damage, St. George Island Bridge, Fla.

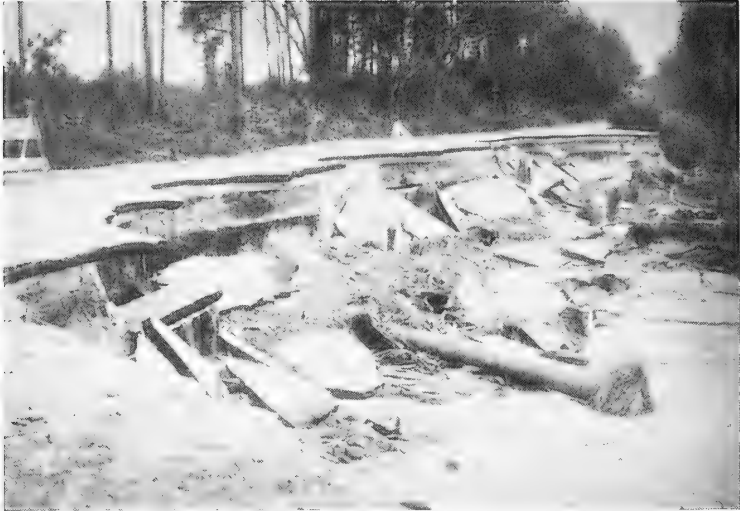
Photo 11. Highway damage between Cape San Blas and Carrabelle, Fla.

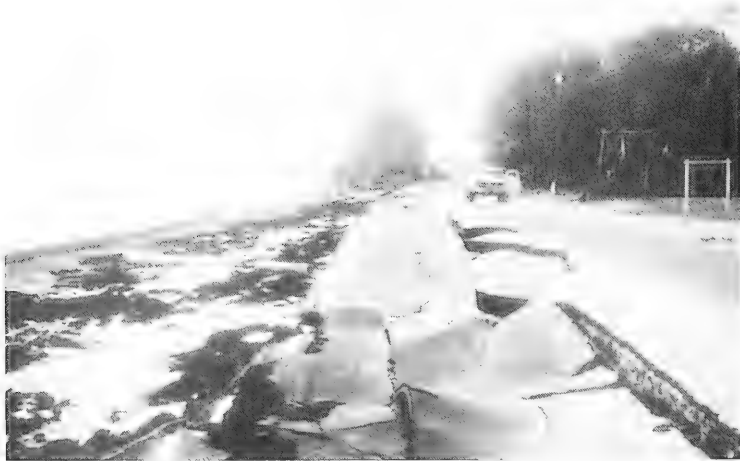
Photo 12. Highway damage near Carrabelle, Fla.

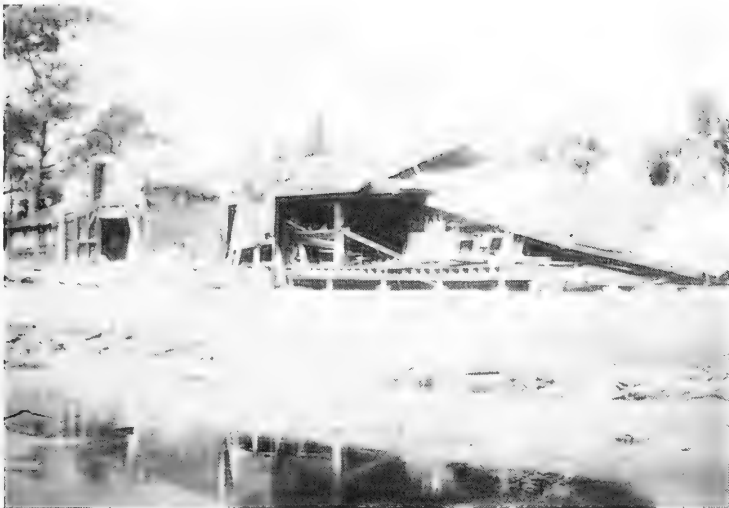
Photo 13. Building destruction, Apalachicola, Fla.

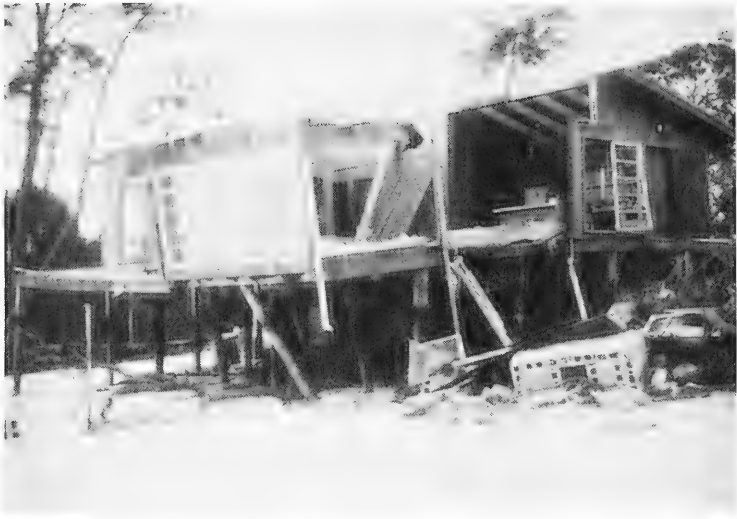
Photo 15. House destruction between East Point and Carrabelle, Fla.

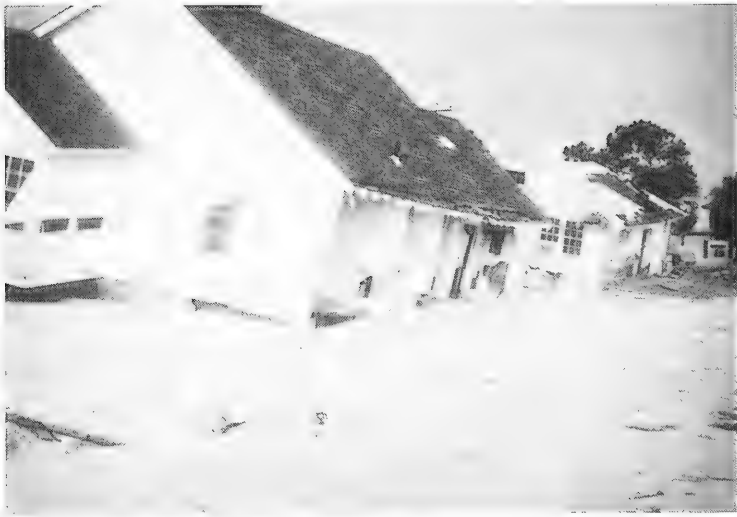
Photo 16. House destruction, Lighthouse Point, Fla.
